Manhole Inspection Summary

Manhole # S23KK_005MH

Insp Date: **7/4/05 7:37 PM**

Location Address: **2435 FRANCIS ST**

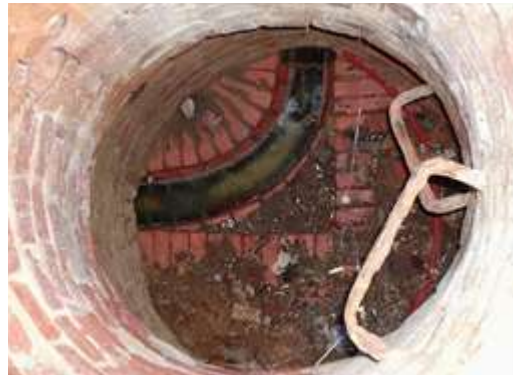
Top View

Corroded steps. Evidence of surcharge - Channel debris.

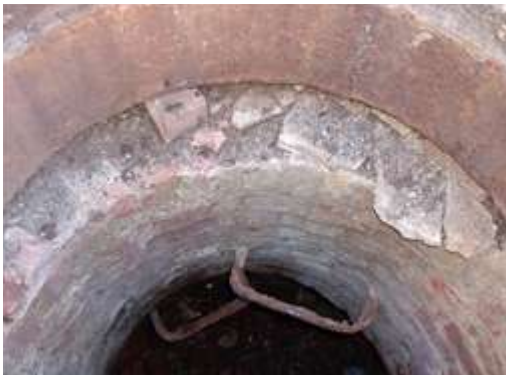
Defect

Frame leaks. Frame offset. Adjustment deterioration, loose brick and infiltration.

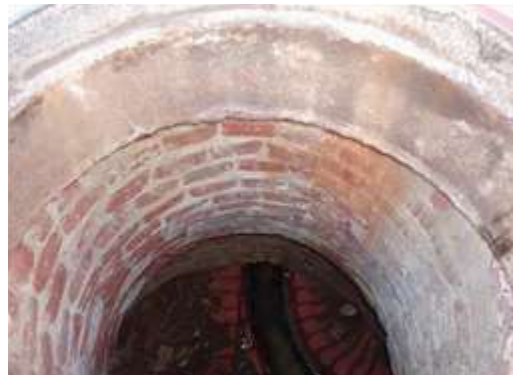
Defect

Frame leaks. Adjustment and Barrel infiltration.

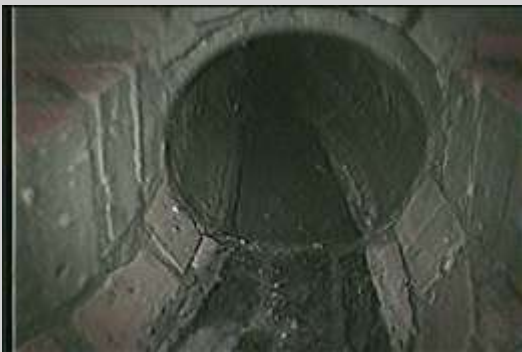
8 in. Circular Gravity Sewer Pipe Out @ 12 O'Clock

Infiltration: **Evidence** Pipe Seal Cond: **Cracked**

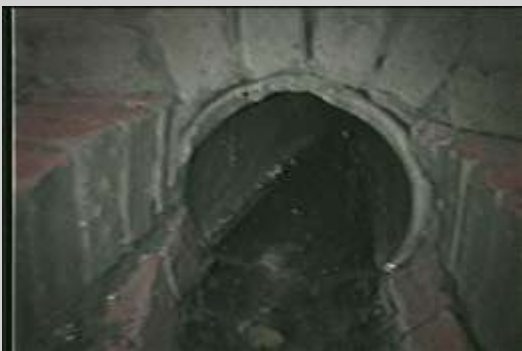
8 in. Circular Gravity Sewer Pipe In @ 9 O'Clock

Deposits: ☐ None ☒ **Mud** ☐ Sludge ☒ **Debris** ☐ Grease

Silt Depth: **0.5** (in.) Deposits Extent: **Light**

Infiltration: **Evidence** Pipe Seal Cond: **Unknown**
